## FINAL FIELD FINDINGS AND DESIGN REPORT

**DATE OF INSPECTION:** June 13, 2013

**PROJECT DESCRIPTION:** DPW Garage Floor Slab Condition Evaluation and Repairs  
126 Ledge Road, Town of Darien, CT  
TranSystems Project No. 712130012

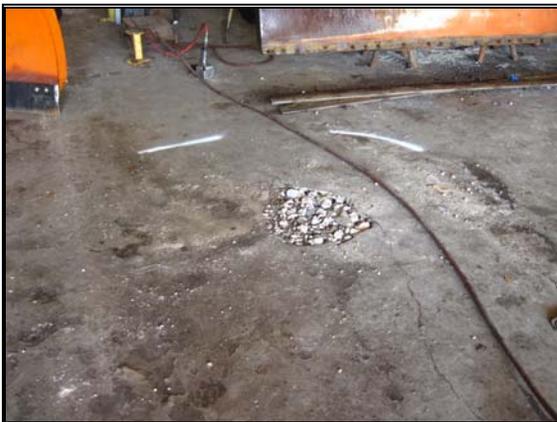
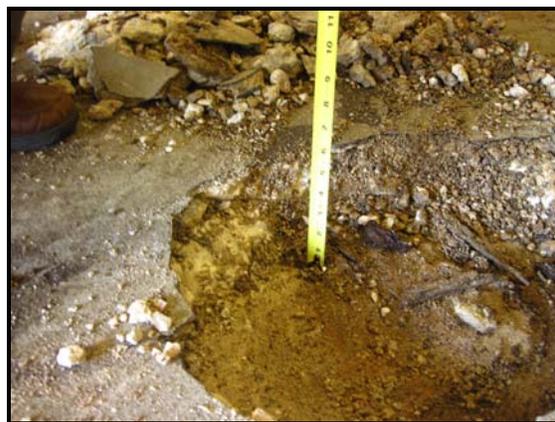
#### 1. **Location:** First Floor Slab Top Surface Deterioration

A condition survey of the top of the garage's slab was performed. The garage can be divided into two sections: the front garage where the trucks are parked and the garage addition which was added in 1977. The inspection was limited to the bays, pointed out by DPW personnel, which exhibited deterioration. The top of the slab was sounded for any hollow areas and at least two of the bays were found to have over 75% of the area hollow, meaning that the reinforcing steel in the slab is likely rusting and de-bonding from the surface concrete. DPW personnel chipped out concrete at one of the hollow sounding locations (18"x18"x4") and it was discovered that the slab's top reinforcement has severe rust with extensive section loss due to its exposure to de-icing agents transported by the plow trucks using the garage.

The top concrete of the slab has extensive mapcracking, full-depth cracks, efflorescence and delaminations. The epoxy resin sealant, applied previously to mitigate reinforcement corrosion, has been fully compromised and no longer serves the intended purpose.

A plow truck, fully loaded with de-icing agent, was driven through the intermediate bay to observe any deflection or widening of slab cracks. No visual evidence of critical slab deflection was noted under the cited live load.

- A. Samples from the bays where the worst deterioration was found indicate that acid soluble chloride levels are over ACI 201.2 and ACI 222 limits (0.2%, by mass of cement, for reinforced concrete in dry conditions 0.1% for wet conditions) and that there is chloride penetration in the full depth of the slab.
- B. The samples taken near the garage truck doorway and in the garage addition show very low acid soluble chloride percentages. The slab in the garage addition is in good condition and is not recommended for replacement.

1. The slab should be removed and replaced within the front portion of the garage where the trucks are parked. Install new floor drains.
2. An externally bonded FRP composite reinforcement system should be installed to strengthen the 12" x 15" support beams for which no reinforcing steel details are known.

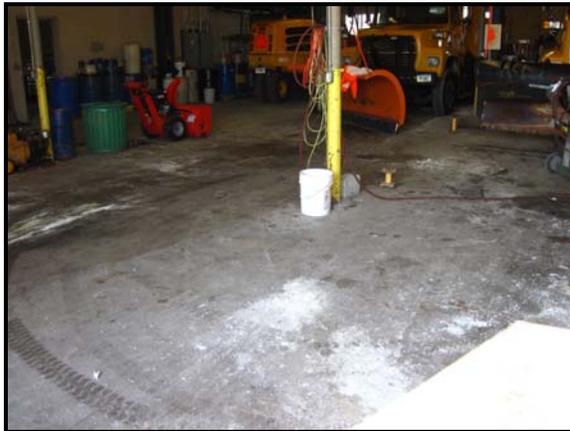
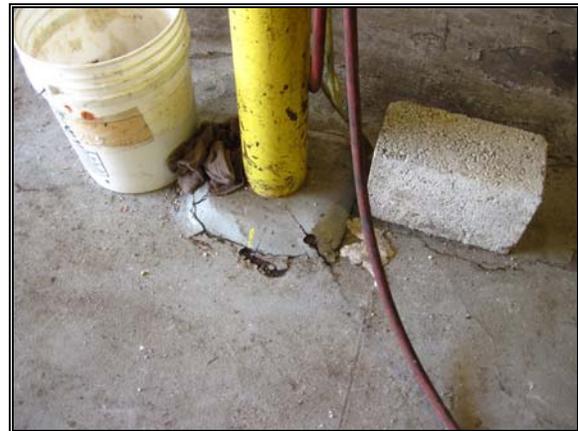
**2. Location: Steel Pipe Support Column Deterioration**

The steel pipe support columns have deteriorated paint (safety yellow – 4 ft. high) and moderate surface rust. Cracking was observed at the concrete column base grout pads, but this does not appear to be related to the slab deterioration. The support columns appeared plumb and there were no signs of buckling.

5. Clean steel columns and base plates. The Engineer or Town's representative shall inspect the connection after cleaning to determine if further repair is necessary. Paint 6" diameter steel pipe columns to the limits depicted on the plans, grout to match elevation of new floor slab.

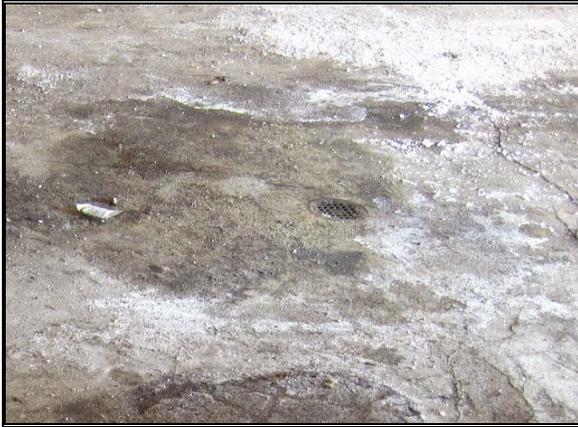
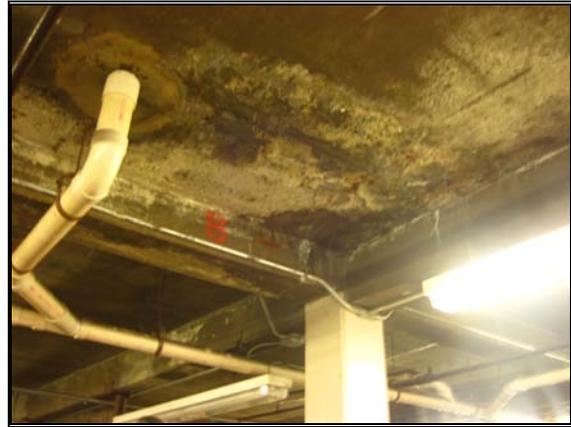
**3. Location:** First Floor Slab Blocked Floor Drains

Floor drains (one in each bay) were partially or fully clogged. The malfunctioning floor drains allow salt laden run-off to accumulate on the floor and permeate the slab, likely contributing to the deterioration. There was significant efflorescence, mapcracking and spalling of the slab's concrete noted within the vicinity of these drains.

6. Place new floor slab and floor drains.
7. Apply penetrating sealer to floor slab.

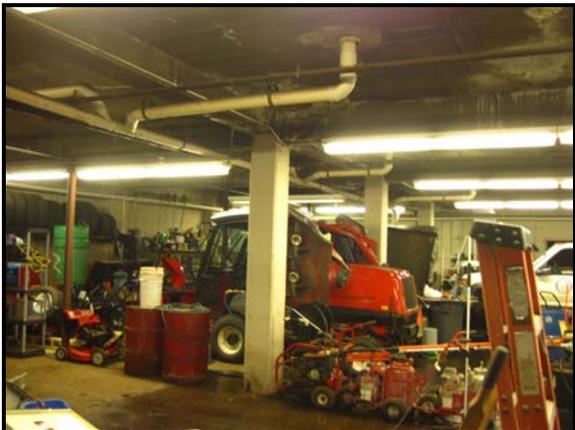
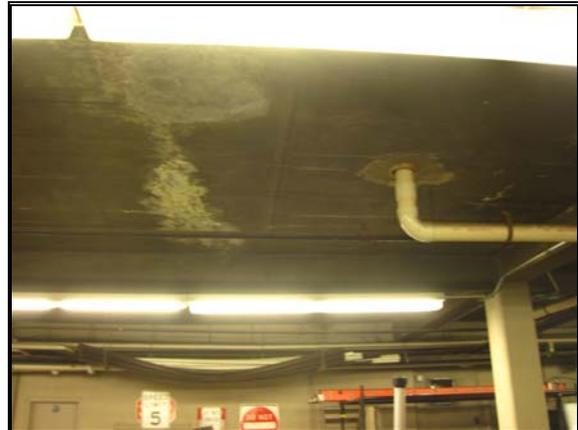
**4. Location:** First Floor Slab Bottom Surface Deterioration and Leakage.

The bottom of the slab exhibits significant efflorescence, mapcracking and spalling of the concrete within the vicinity of the drains and along the cracks following through from the top of the slab. At a couple of locations, within the intermediate bays, continuous dripping of water was noted. The exact source of the leakage was not identified, however, the clogged drains are suspected of facilitating water seepage into the slab.

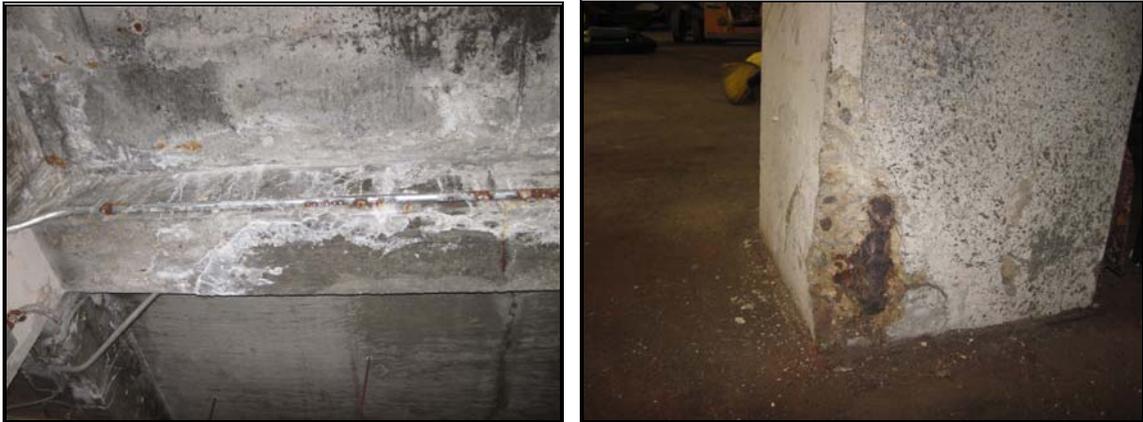
5. **Location:** First Floor Slab Support Beam and Column Deterioration.

The stems of the T-beams supporting the slab exhibit heavy efflorescence, water staining and mapcracking, typically in the vicinity of the floor drains and in areas of the worst slab deterioration. The support beams were sounded at scattered locations that had water staining and mapcracking. No hollow sounding concrete was noted.

A spall was noted at the base of one column, exposing rusted rebar.

2. Install FRP reinforcement on the reinforced concrete support beams in the front portion of the garage. This step will eliminate the need for temporary bracing during construction.
